Donner Lake:  
A Pearl in Peril

2022-2023 Nevada County Grand Jury

Report Date: May 16, 2023

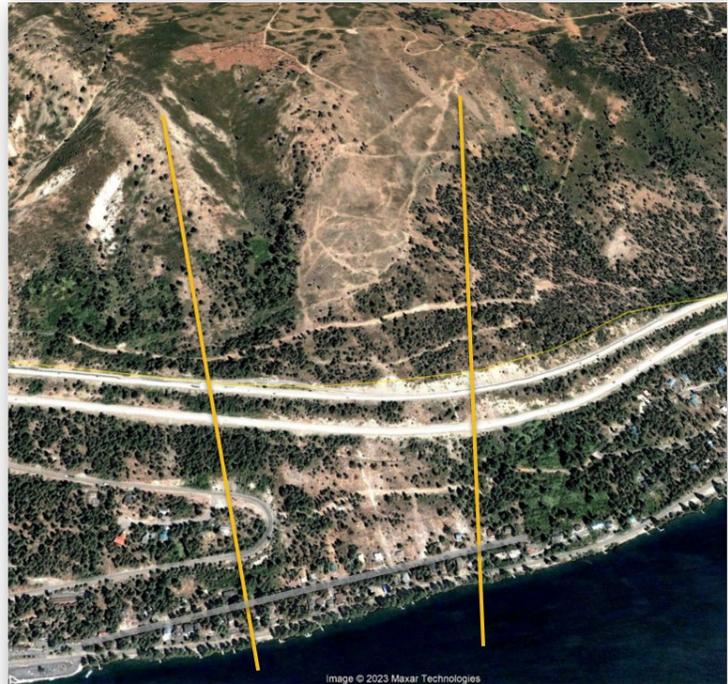
The location specific to this report, 1,500 feet of steep hillside assessed to be at the highest level of risk for erosion and landslides, a location that carries polluted runoff from I-80.

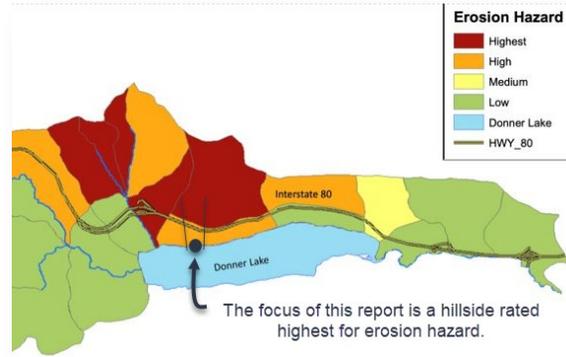
In the immediate vicinity of the lake, the highest erosion hazard exists on the north side of Donner Lake, above I-80. The focus of this report is a location where the most erosive soils coincide with the steepest and most barren slopes.

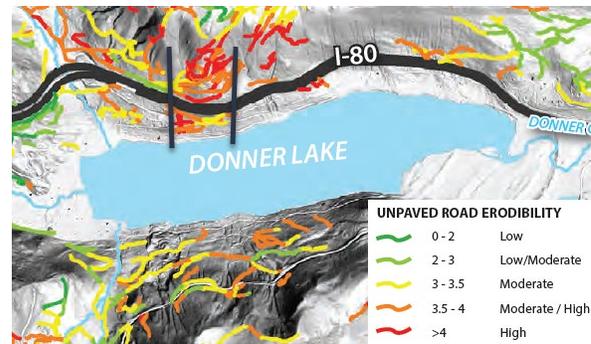
This location has the highest density of backcountry roads. These destabilize hillsides and contribute large amounts of sediment to runoff.

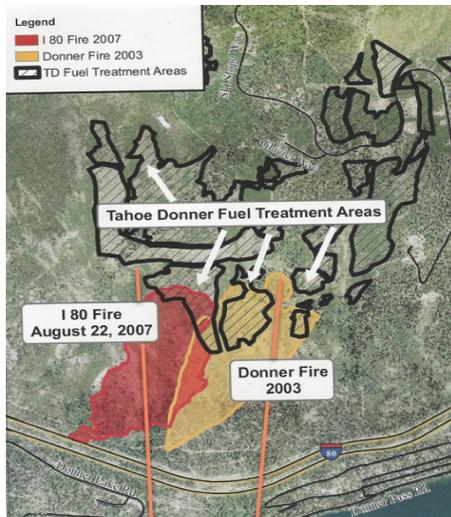
The focus of this report is a hillside that has been denuded by three forest fires in 63 years. (1960 Donner Ridge Fire not shown.)

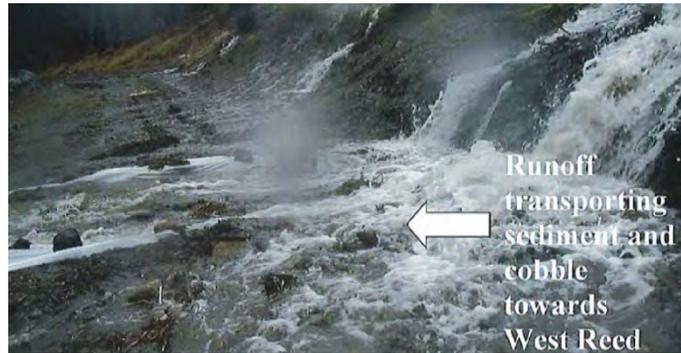
Water and electric utilities buried under unpaved road without drainage mitigation on hillside below I-80, above Reed Avenue West, Donner Pass Road, and Donner Lake.

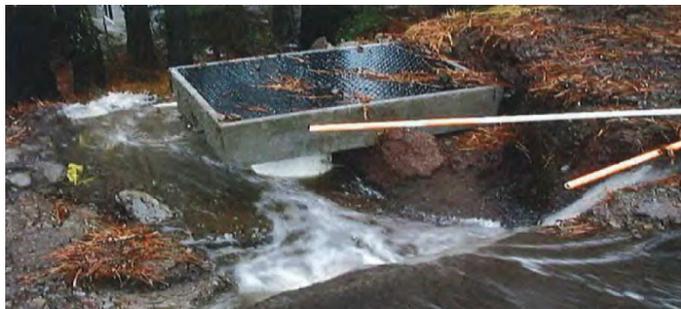
Utilities connecting West Donner to East Donner and located along Reed Avenue West compromised by runoff.

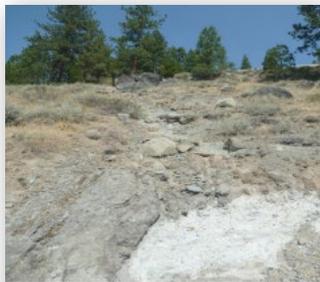
Channelization from I-80  
looking uphill

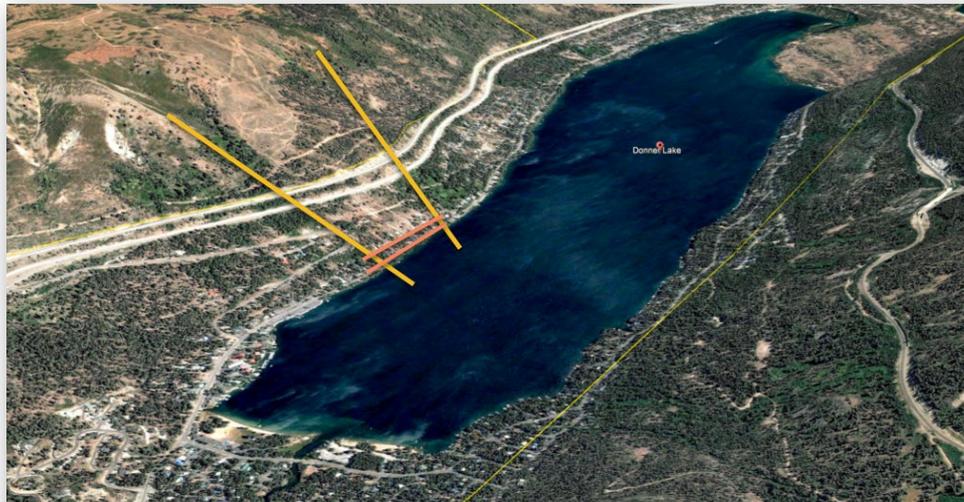
The focus of this report is a hillside and drainage that is unique in the Lake basin due to the extreme lack of vegetation, its length and steepness, its erodability, and the concentration of freeway drainage all funneling stormwater (sediment and pollutants) runoff down to and sometimes into the homes of the residents of Reed Avenue West and Donner Pass Road, shown in orange, and then into Donner Lake.

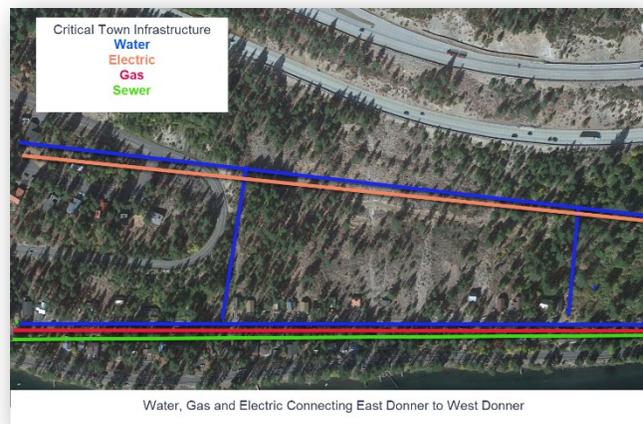
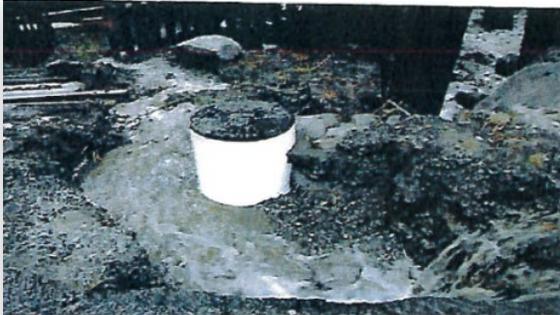
Utility infrastructure on Reed Avenue West

The existing infrastructure for Reed Avenue West will be at risk if the hillside-drainage issues remain unattended. The risk is to the health and safety of Truckee residents and visitors. [[Finding](#)]

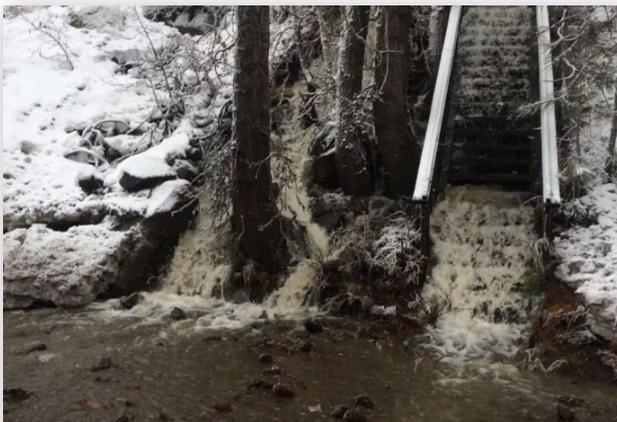
Stormwater from the hillside moving down from Reed Avenue West onto Donner Pass Road and into Donner Lake

The volume and velocity of runoff from the hillside and I-80 seasonally overwhelm Reed Avenue West, which further degrades its surface, adds pollutants to stormwater, and threatens utilities buried under its length. Sometimes, stormwater runs into and through the homes of residents who live on this road.

The Town must decide on repair and maintenance of the road, but the Jury believes that funding that addresses hillside issues—erosion, unchecked runoff, utilities, human safety, and pollution—must also address the Reed Avenue West problems. [[Finding](#)]

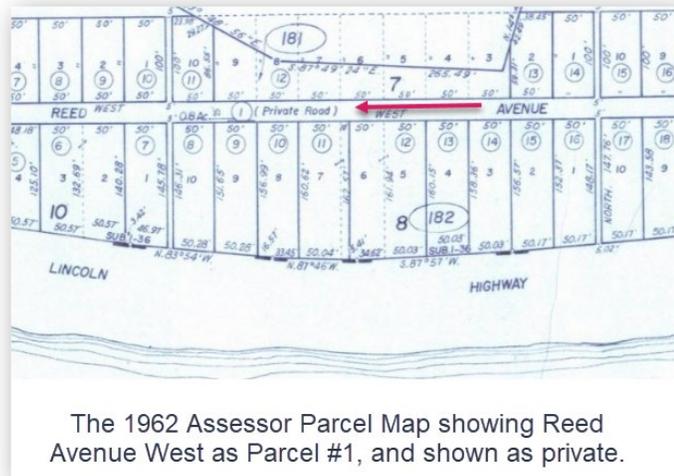
The 1962 Assessor Map page had erroneously shown the street with its own parcel number and labeled as Private.

The 1962 Assessor Parcel Map showing Reed Avenue West as Parcel #1, and shown as private.

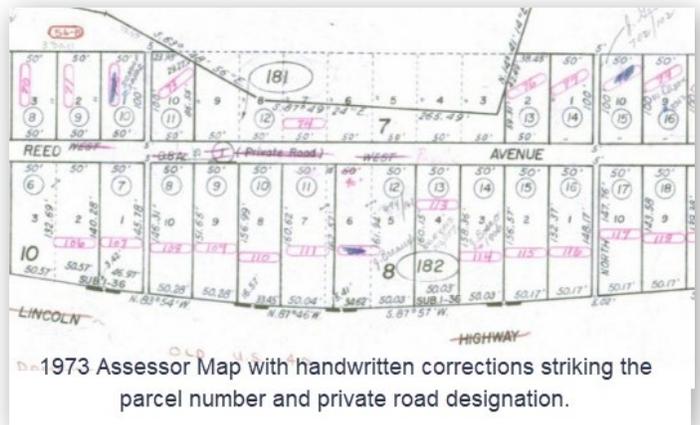
1973 Assessor Map with handwritten corrections striking the parcel number and private road designation.
